## **ALKALI STAINING**

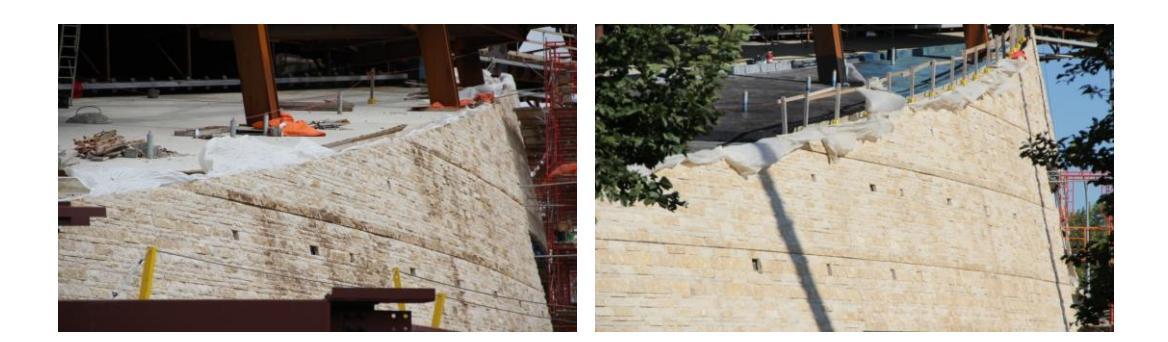
## **BEFORE NATURAL WEATHERING**

## AFTER NATURAL WEATHERING

Brown staining, in particular found on Buff coloured Tyndall Stone is symptomatic of alkali staining that occurs on several limestones, used for masonry veneers.

"This stain is caused by alkali-charged moisture which permeates the limestone from its back or bottom bed. It cannot be produced in objectionable form by moisture absorbed through the stone's exterior face. (Ground moisture absorbed by the stone's face when below grade is an exception to this rule.)

The source of the alkali is usually nearby concrete walls, floors, or grade. The moisture may be rainwater, wash from concrete pours, excess moisture in mortar, or moisture from or at grade. This moisture picks up water-soluble free alkali from various sources as it migrates to an evaporation surface at the stone's above-grade face. Alkali-laden moisture moving through the stone dissolves minute bits of organic matter. The material is transported to the face of the stone as the moisture moves toward the face. The moisture then goes off as vapour, leaving the alkali and organic matter at the surface in the form of stain."

**REMEDY: NATURAL WEATHERING**
